Thermal Imaging Analysis

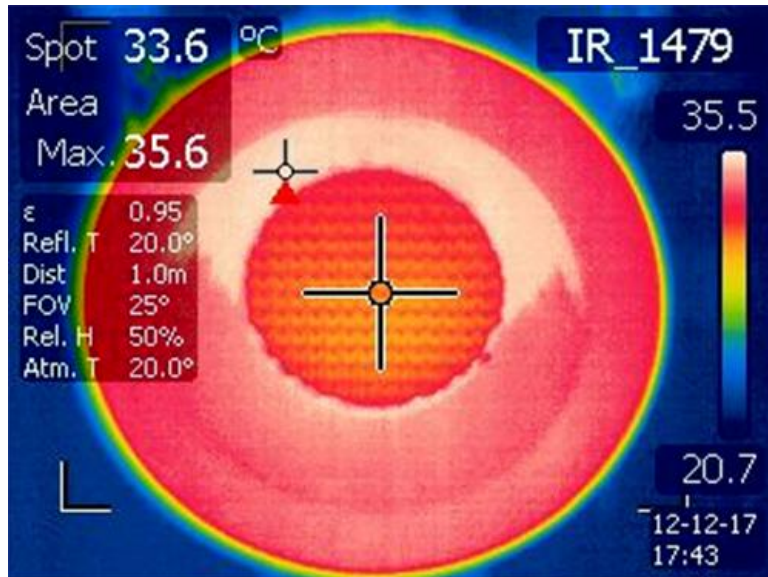
Figure 12: Thermal Image #1

With the sample at steady-state temperature, a series of infrared (IR) imaging photographs were taken using a FLIR T300 to evaluate thermal dissipation and areas of concern on the light engine, heat sink, and external housing. The FLIR camera, when used in this way, gives primarily qualitative information. Without precise per-material emissivity calibration, the analysis will not provide exact correspondence to other temperature measurements.
